**POSTĘPY W INŻYNIERII MECHANICZNEJ
DEVELOPMENTS IN MECHANICAL ENGINEERING**

**EVALUATION OF INTERNAL QUALITY
AT MANUFACTURAL CORPORATION**

Summary: This work is focused on evaluation of internal quality in manufactural corporation. Huhn PressTech Ltd. is a company producing metal products as results of pressing process, construction units and other components used in automotive industry. The aim of the article is to review the process of internal quality evaluation method on daily basis. Constantly growing demand on metal chipless machining replaces the older chip`s technology. This paper aimed to clarify, how the company performs fault evaluation and what is done for their correction. To explain the procedure of evaluation in detail and demonstrate the solution, there were artificially made parts 3333 and 5555 in the company. The result is called Quality Alert.

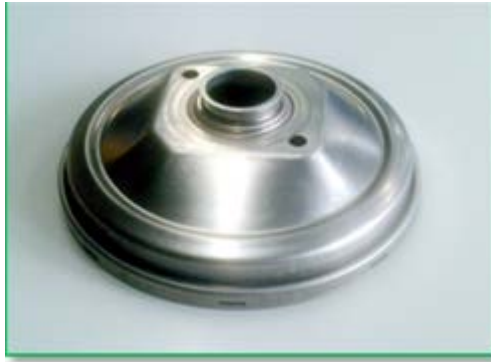
Products are made on transferred and processed machines. On transfer machines, there are units moved along the transfer on production line type Raster 630t. The example of a big unit is in Fig. 1. The small pieces, such as

Fig. 1. Cover

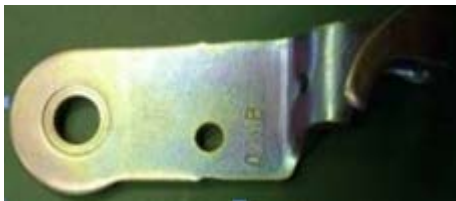
control lever or cable support, are made by processed machines. The example of a small piece is in Fig. 2.

Fig. 2. Control lever

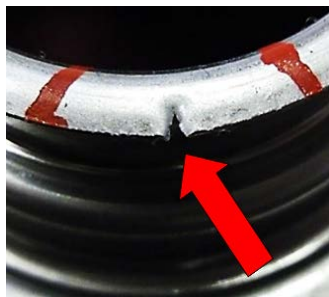
Fig. 5. Cover (crack)

Operators of pressing machines and workers of 100% control are ordered to separate units if there were found minimally 10 n. i. o. pieces of unit with the specific type of fault (burr, crack...). These pieces are separated with description (the number of unit, the amount of units), marked fault on the surface and placed nearby pressing machine (in red box) that produces this unit. On the workplace of 100% control, it is placed in the container which is given for this order. It is important to take a photo of the unit, the date code and the fault and it has to be admitted to defined cell – Fig. 5. If the unit, addressed to photo documentation of the fault, is not placed on pre-defined place, it is needed to closely specific defined fault. For example, the dialog with the operator who made the mistake or controlled it on the workplace of 100% control and report it to the cell could be useful. Examples of faults from photo documentation:
